Mobile Intel® Pentium® 4 Processor Supporting Hyper-Threading Technology on 90-nm Process Technology

Specification Update

November 2004

Document Number: 302441-005

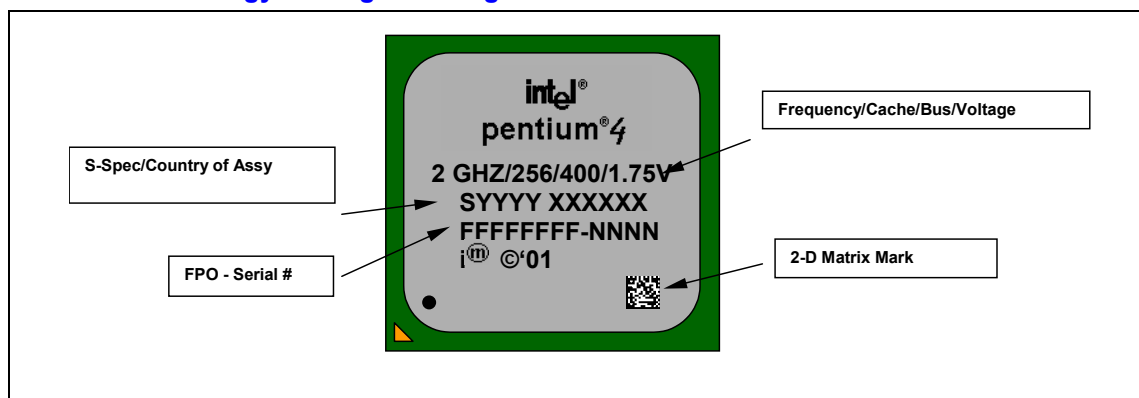
Figure 1. Mobile Intel® Pentium® 4 Processor supporting Hyper-Threading Technology on 90-nm Process Technology Package Markings
